55 Seconds That Shook Garhwal  
- A Reconnaissance Survey Report -

November 1, 1991.

## A Reconnaissance Report

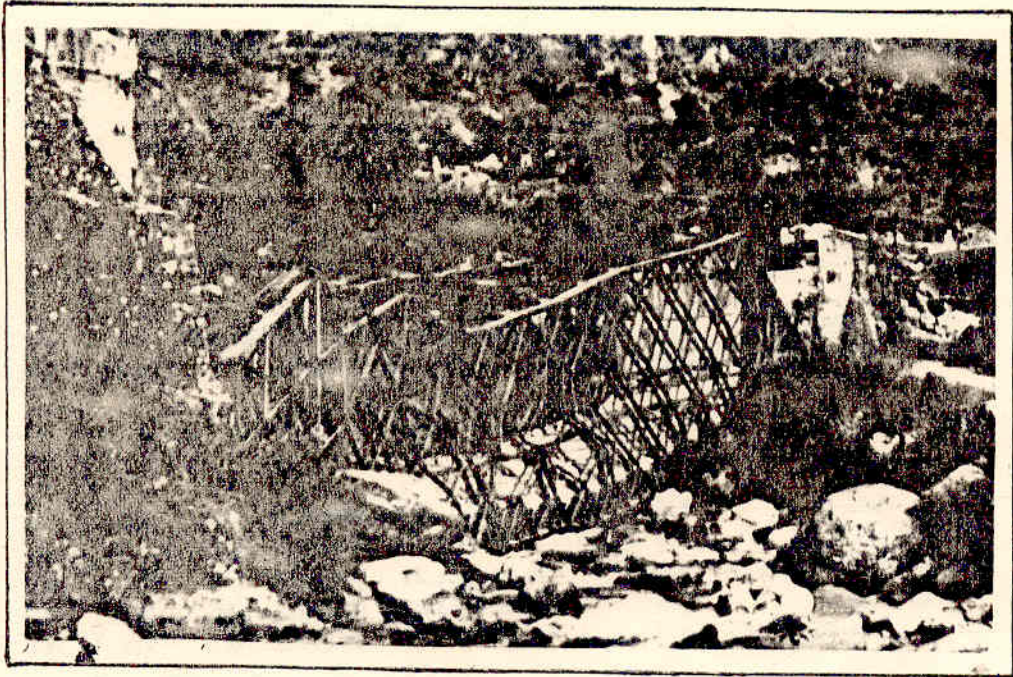
Infrastructural Damage : (1a) Collapse of the Maneri - Bhatwari bridge on the main road to Gangotri. (1b) Power lines and tele-  
phone poles uprooted in Maneri village.

As expected, the intensity of the destruction varied inversely with the distance from the epicentre. In the region of Uttarakashi visited by PSI, the destruction was massive. Deaths of human beings and livestock resulted almost exclusively from house collapses, while infrastructural damage -- roads, terraced fields, power lines resulted mainly from landslides (Pictures 1a and 1b).

The collapse of the Uttarakashi -- Maneri link bridge (see Picture 1a) forced the team to take a detour from Gangori to Agora, the quake's epicentre. Extensive damage was visible along this road. After the village of Rawar (2km from Gangori) the road was blocked by continuous landslides. The team trekked another 4km to Kalyani. Here the road was blocked at many places by massive boulders (usually limestone) -- Picture 3b. Even trekking beyond this point was difficult, though people could be seen doing it.

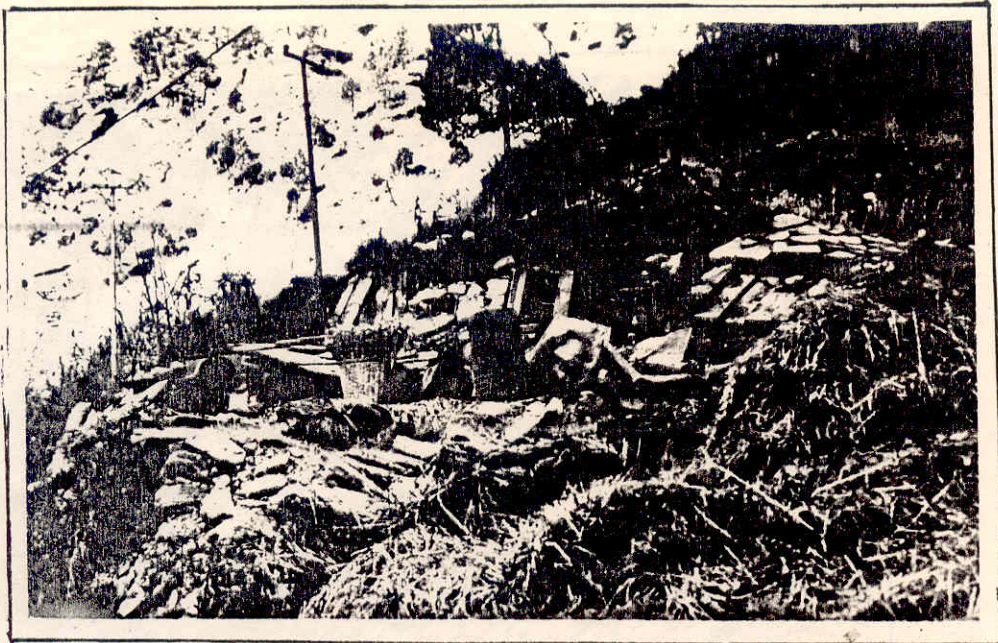
Housing Damage : (2a) In Sanglai village, the destruction was total. (2b) In Tehri-Garhwal, though most of the structures were standing, the damage was serious.

In the surveyed area of Uttarakashi, most houses had either collapsed or were seriously damaged. In Kalyani and Sanglai villages, the destruction was total (Picture 2a). The same appeared to be the case in Agora, the epicentre of the earthquake. In these villages, even the newer concrete structures had collapsed.

It appears, therefore, that the death toll is almost entirely due to the use of inappropriate building materials, particularly slate roofs. Pointing to a collapsed structure, a villager in Sanglai said, "We have been killed by such big houses. A tin roof would have been better." With wood becoming

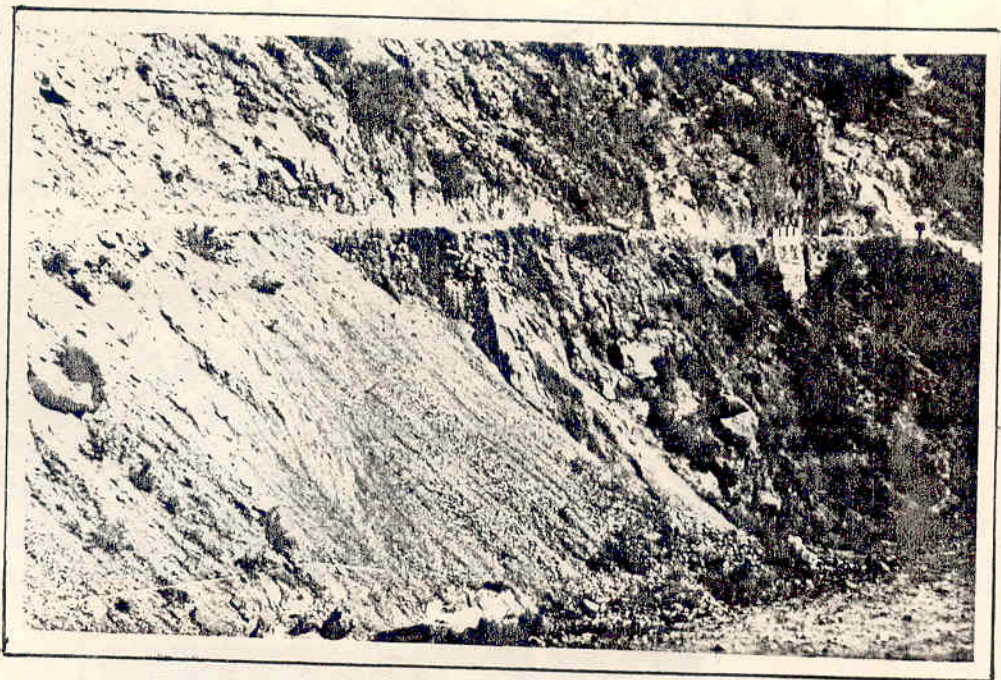
Landslides : (3a) In Uttarkashi, hill slopes where roads had been constructed suffered extensive damage. (3b) Massive boulders had blocked the road to Agora, the quake's epicentre.

Major landslides due to the earthquake, become continuously visible when moving beyond Uttarakashi town into Bhatwari tehsil and beyond (Picture 3a). Roads appeared to be both a cause and the victims of landslides. In contrast, trees appeared to have arrested the damage at several places.

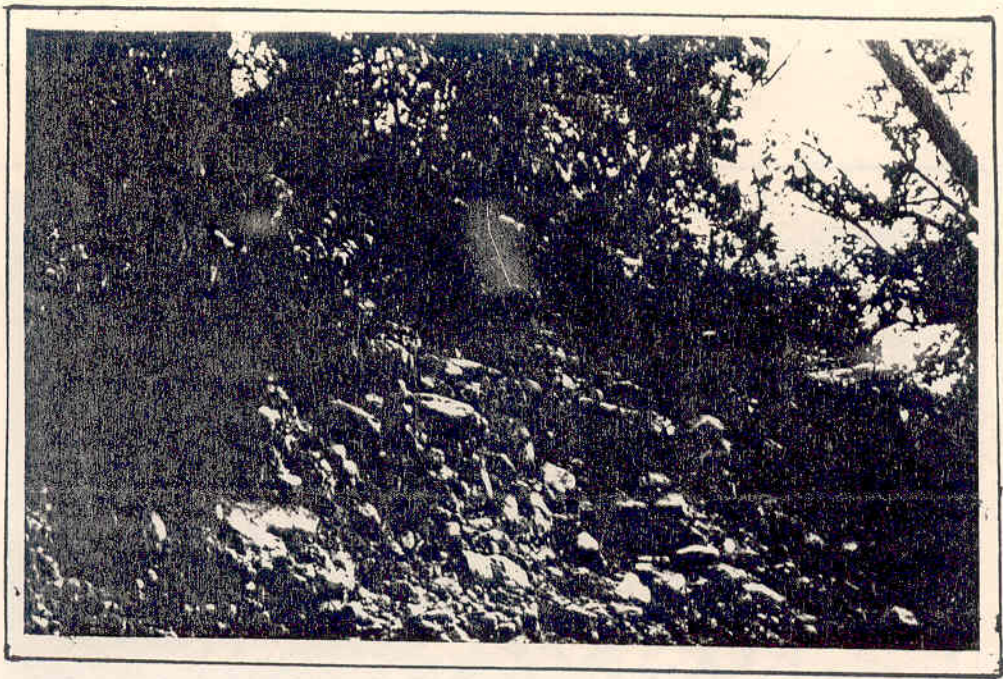
Landslides: (4a) Despite the massive erosion, trees were still standing on the road to Kalyani. (4b) A massive landslide in progress on the Uttarkashi-Maneri road on 29.10.91. The debris were falling into the Bhagirathi river.

An interesting feature of the stretch from Gangori to Kalyani was that at several sites, trees seemed to have withstood the landslides and at places even arrested them (see Picture 4a). Landslides were almost continuous along the slopes where the road had been constructed. These observations bring to the fore the

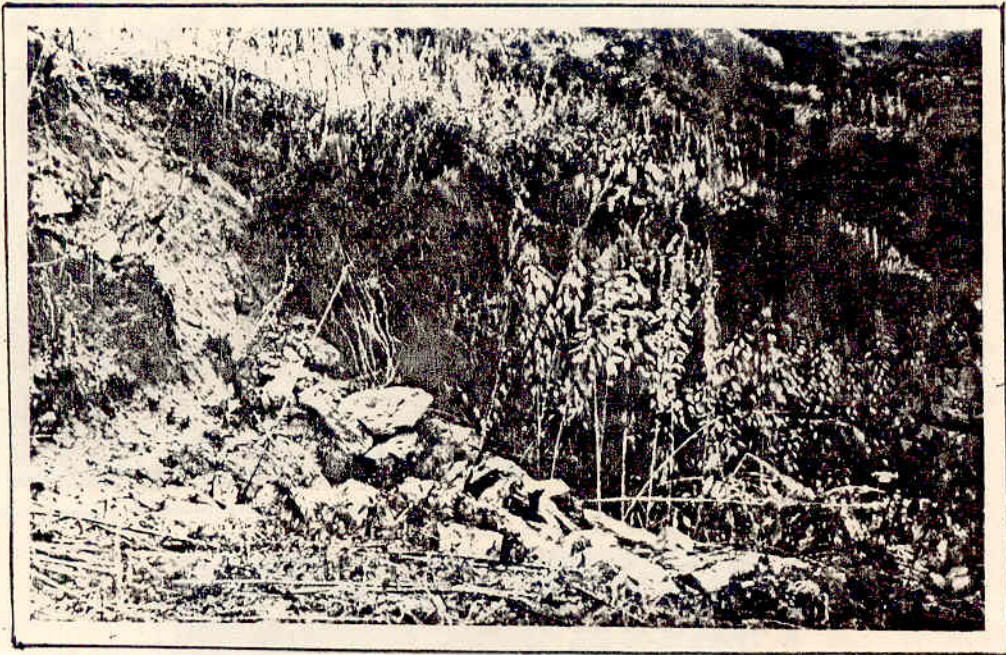
Agricultural Damage : (5a) Terrace wall destroyed by fallen rocks.  
(5b) Destruction of standing crops in Sanglai.

The earthquake appears to have affected agricultural fields and production mainly in Uttarakashi. The kharif crop had been harvested in Tehri-Garhwal before the earthquake. Rock and landslides in Uttarakashi had damaged terraced fields and the crops standing on them in several villages (see Pictures 5a, 5b). The irrigated (paddy) crop had been harvested already. It is mainly the coarse cereale crops, meant for personal consumption

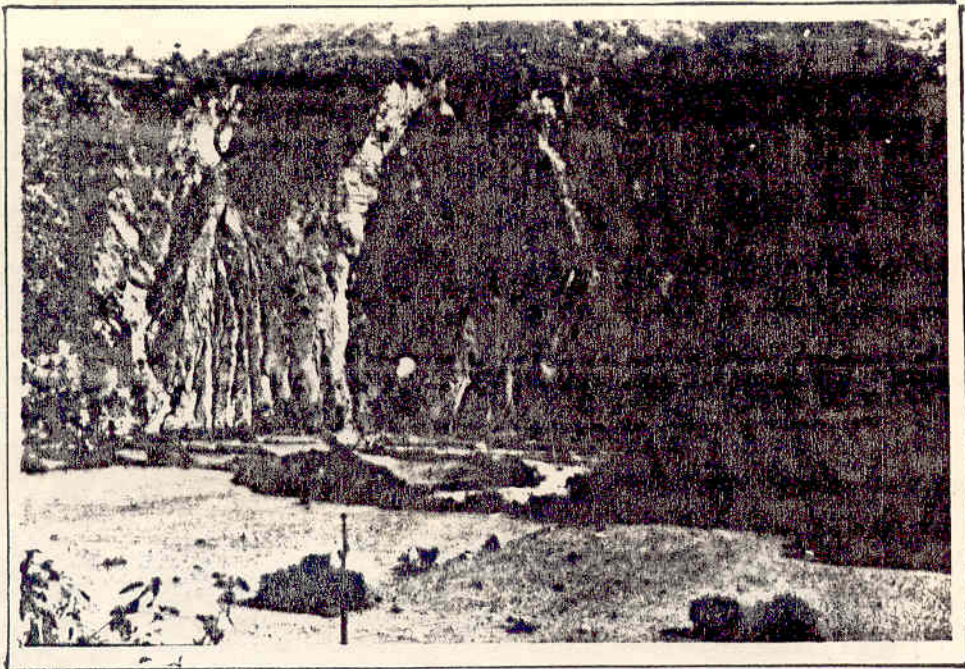
Fragile Slopes : (9a) The fragile slopes along the Bhagirathi valley near Tehri. (9b) Debris almost blocks the Bhagirathi below Sanglai village.

We did not survey the dam site. But all along the valley, we could not help noticing the fragility of the mountain slopes (see picture 9a). At Sanglai, debris falling into the river had almost totally obstructed its flow (picture 9b). Thus, in a major earthquake, even if we accept for a moment, that the dam will withstand the shock, what will protect these fragile slopes from tumbling into the reservoir?
