EARTHQUAKE-RESISTANT TRADITIONAL ARCHITECTURE IN UTTARKASHI

a photo-essay

THE PHEROLS OF UTTARKASHI *

BASIC FEATURES OF EARTHQUAKE-SAFE CONSTRUCTION

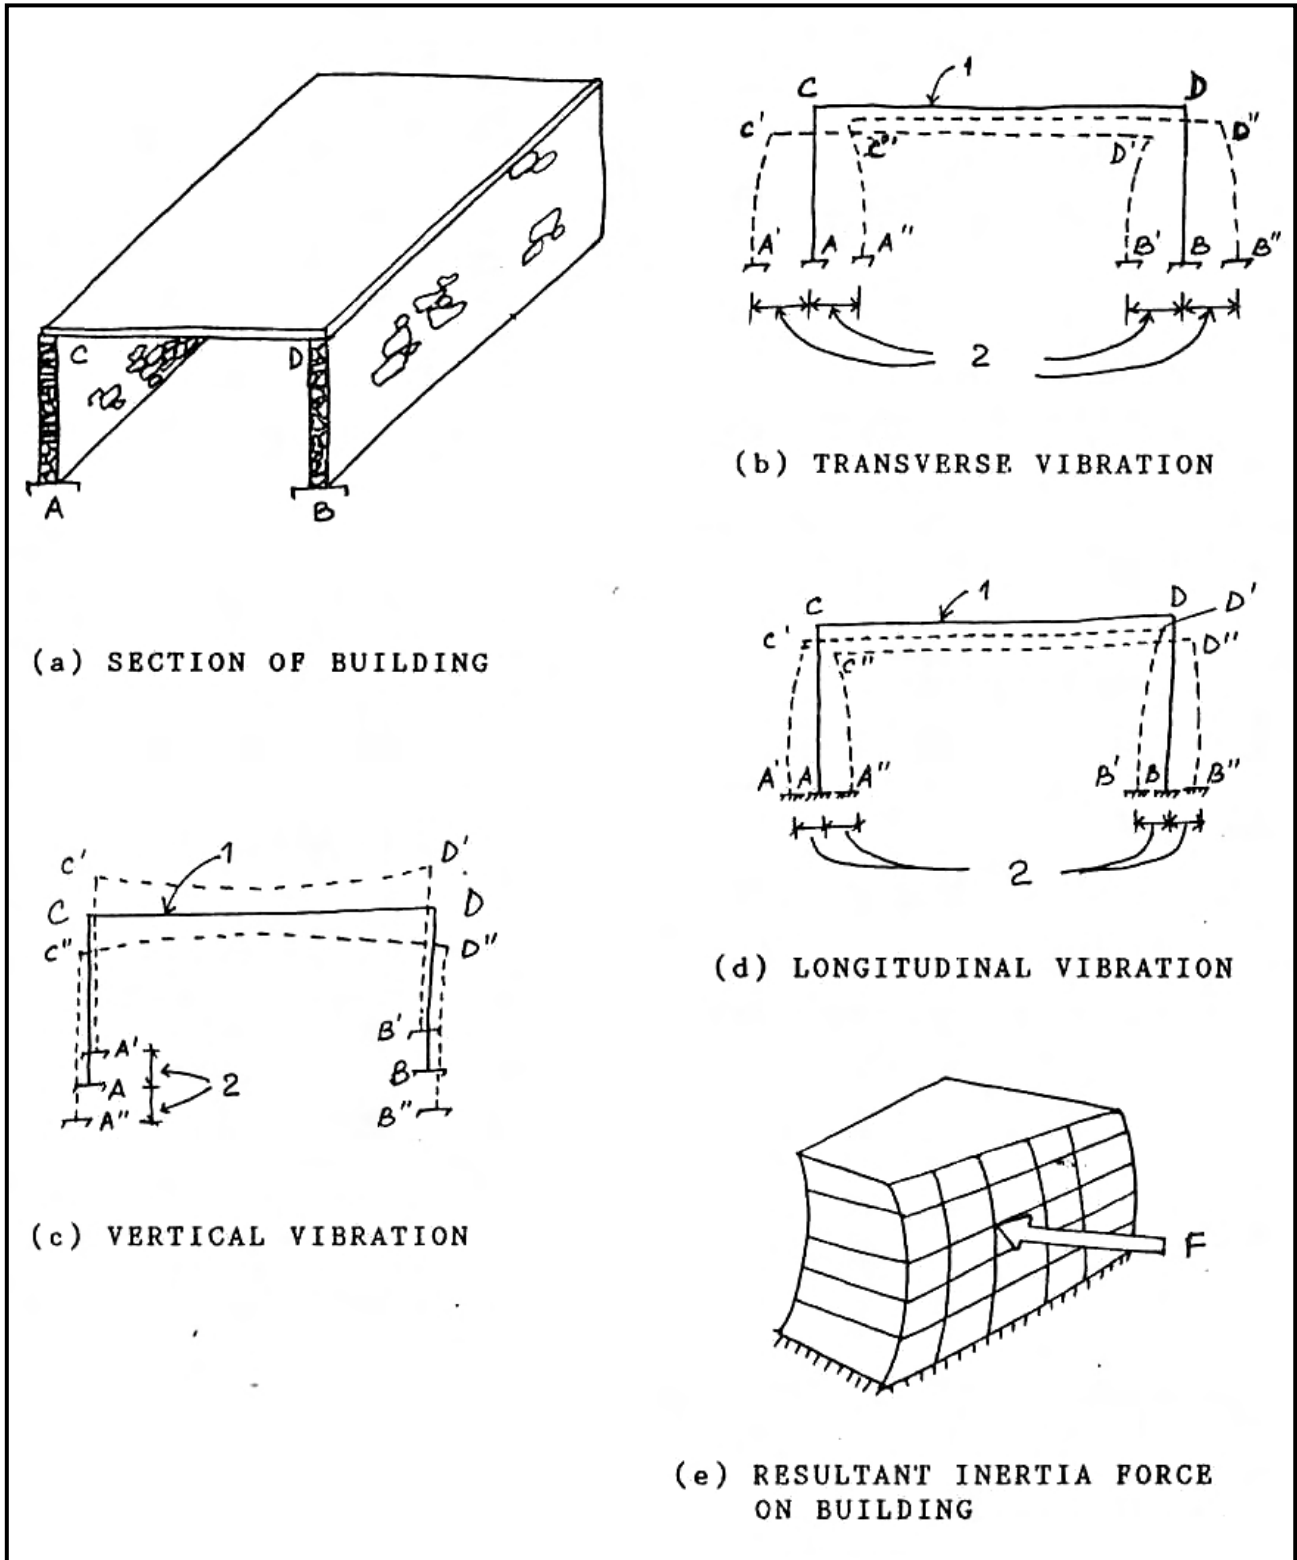
FIG 1: IMPACT OF SEISMIC VIBRATIONS

The main cause of buildings' damage in an earthquake is ground movement. A building is fixed to the ground at its base (Fig 1a). When the

ground moves to the right, the base of the building also shifts suddenly to the right. But, because of its mass, and hence inertia, the rest of the building tends to resist this movement to the right, resulting in deformation of its superstructure (Fig 1b). The effect is as if the building was pushed to the left, relative to its base, by an imaginary force that is called the 'Inertia Force' acting at the centre of gravity of the building. This causes severe deformation of the superstructure.

In reality, the seismic forces acting on the building are very complex, since the ground moves in the three orthogonal directions almost simultaneously. The net result is equivalent to a horizontal seismic force (or load) acting on the building as shown in Fig 1e. This inertial seismic load on a building is a function of its mass and

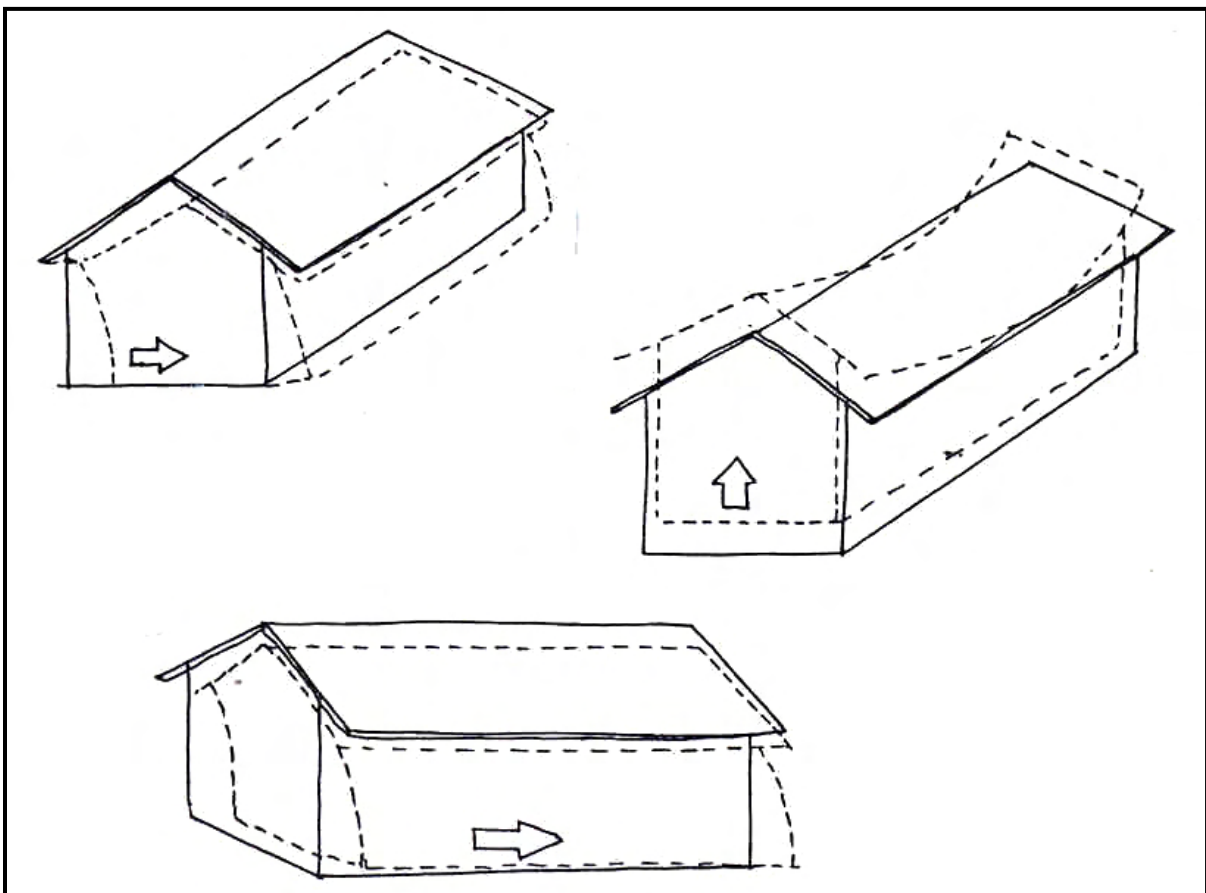
FIG 2: DEFORMATIONS PRODUCED BY SEISMIC VIBRATIONS

Under normal conditions, the different structural elements bear only vertical loads and are thus subjected to compressive loads. During an earthquake, there are additional horizontal, reversible seismic loads, giving rise to tensile and shear stresses in various components of the building. These stresses give rise to complex deformations in buildings (Fig. 2). Hence high tensile and shear strengths are important for quake-proofing.

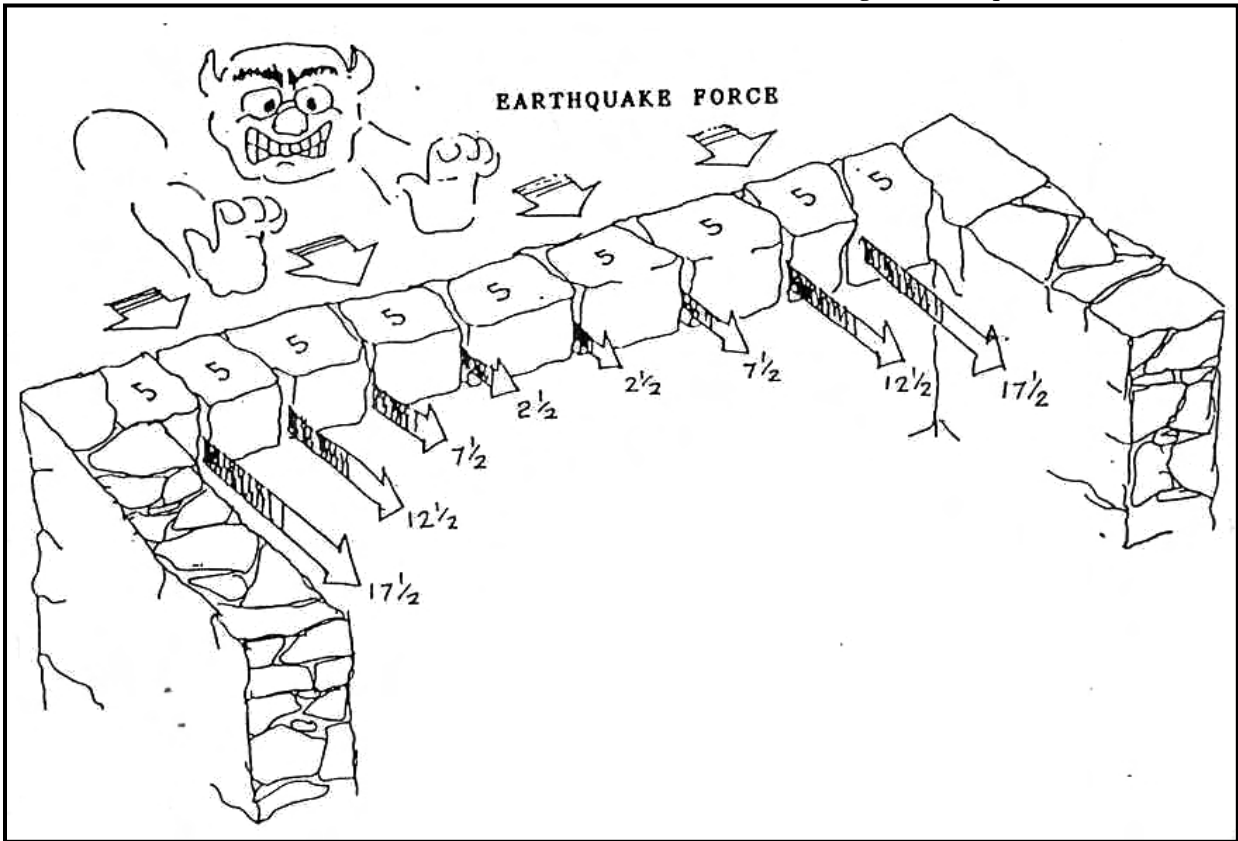
FIG 3: CORNERS EXPERIENCE LARGER FORCES

Each unit of a building, e.g., a brick or a stone, tries to distribute the stresses on it over the adjacent units. The maximum build-up of stresses thus occurs at the corners of the building or at corners of openings (Fig 3). Hence corners need to be reinforced.

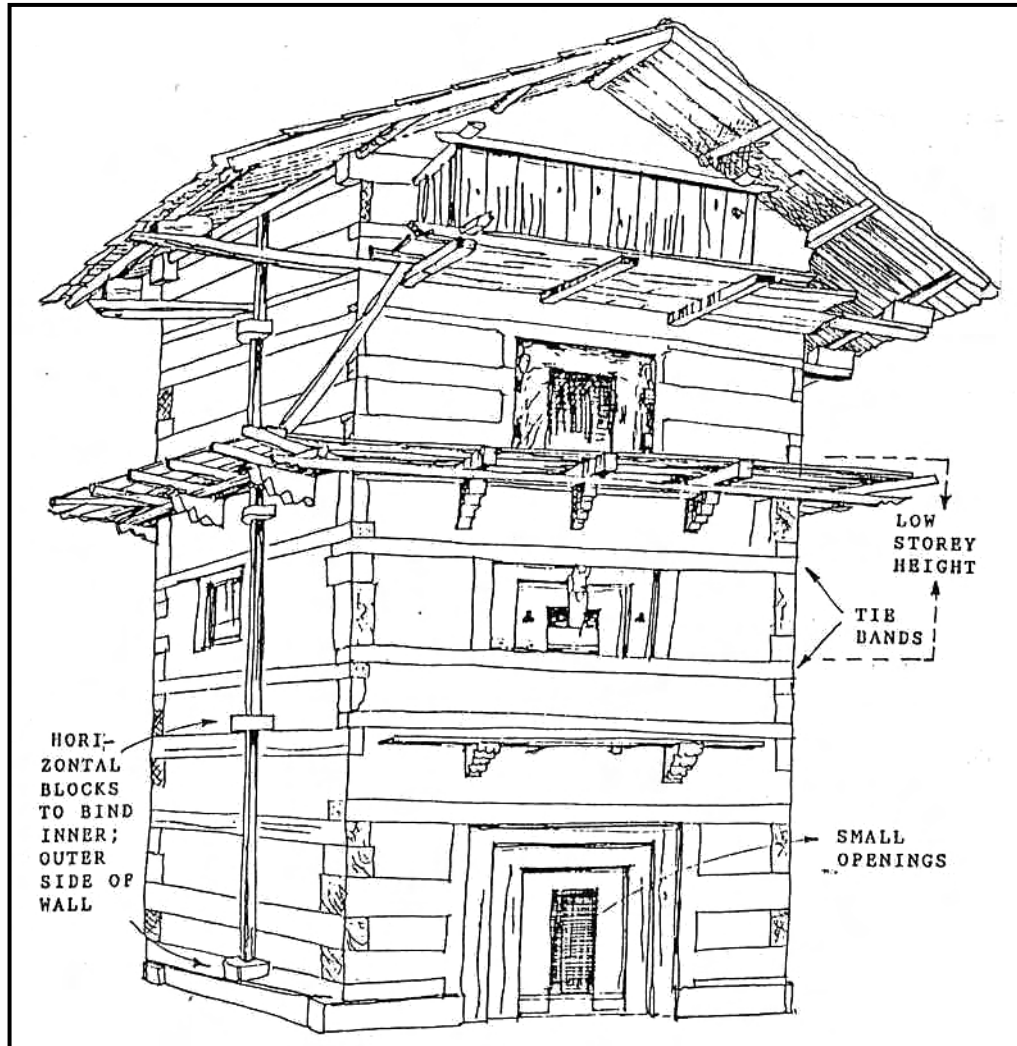
FIG 5: QUAKE-PROOFING FEATURES OF A TRADITIONAL HOUSE IN THE YAMUNOTRI VALLEY

Figure 5 is a sketch of a traditional earthquake-safe house in the Yamunotri Valley of Uttarkashi. The main features of quake-proofing that can be identified in these type of houses are:

1. **Tie-bands:** The use of wooden beams as tie-bands are the most prominent feature. The wooden

beams also serve to course the rubble masonry.

2. **Tying of Inner & Outer Walls:** The walls are made of coursed rubble masonry, using wooden beams. They are thick – usually 45 to 50 cm across – to provide insulation during the bitterly cold winters. Since the width of the masonry stones is much less than the width of the wall, there is a need to tie the

- inside wyeth and the outside wyeth of the wall. This is done by using horizontal wooden blocks with vertical timber columns acting as pins to tie the inside and the outside wyeths of a wall.

3. **Use of long flat stones:** Long stones with flat surfaces are well-distributed in the walls. The flat surfaces help to make the loads vertical in the wall units and minimize the tendency of the wall stones to push or run outward.

4. **Corner reinforcements:** The corners of a building are reinforced by the use of wooden blocks in the outside walls. They help distribute some of the seismic loads vertically. The use of long flat stones, at 90° to each other, at the corners also enhances their strength. Inside too, diagonal braces are used to maintain their perpendicularity and strengthen corners.

5. **Low storey heights:** Though most pherols are four or five storeys high, the heights of the floors are low, thus keeping the centre of gravity of the entire building low.

6. **Small Openings:** Doors and windows are kept to a minimum and so are their sizes. Though this is done most likely for insulating purposes, it also serves to improve the earthquake-resistance characteristics of the building.

7. **Quality of Construction:** This is particularly evident in the carefully crafted joints. Wooden dowels and cotter pins are used to connect wooden beams. Beams of roofs are held down in slide off. The careful joinery also helps to enhance the interconnectedness of the entire structure.

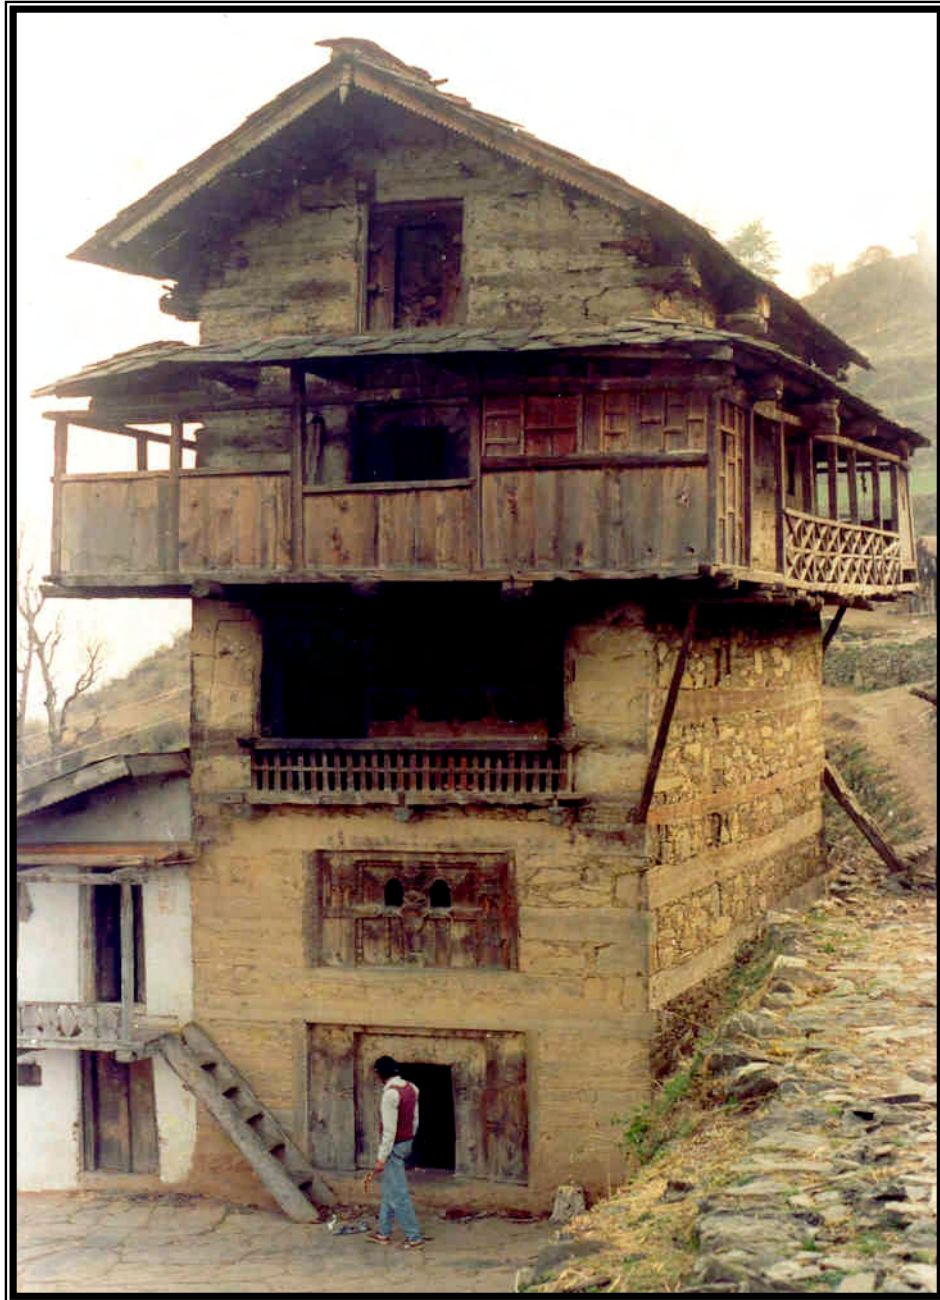
A five storeyed house, about 125 years old in Raithal village, Uttarkashi, that withstood the earthquake in 1991. Most of the other houses in the vicinity were partially or fully damaged.

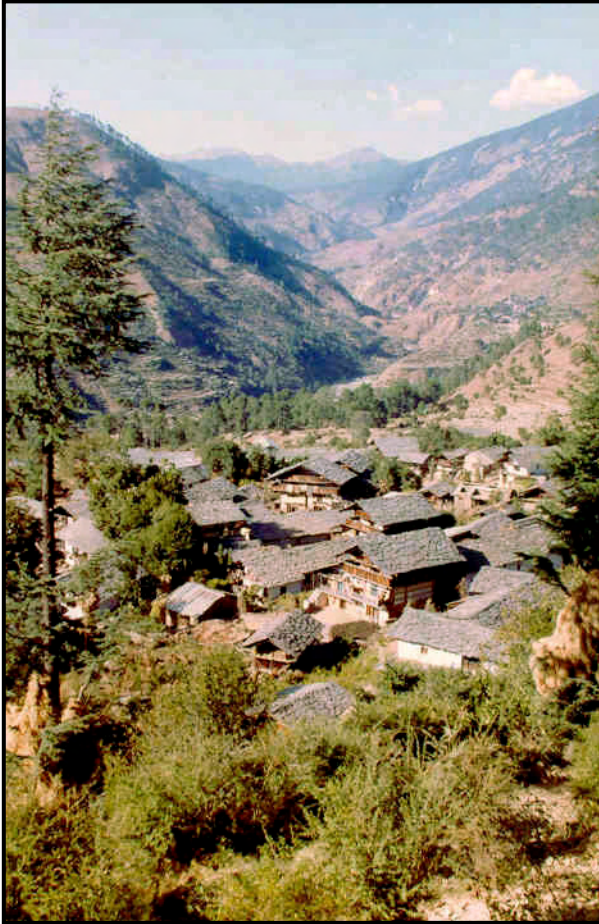
Traditional earthquake-resistant houses in Nandgaon village, Yamnotri valley. These houses are more than 100 years old. The main construction materials are mud, stones and timber.

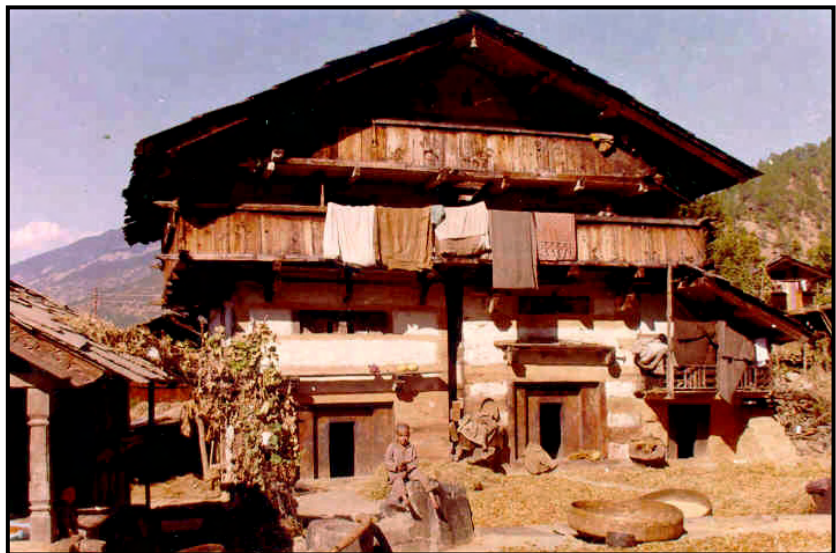
One of the four storeyed earthquake resistant structures in Nandgaon. This 125 year old structure is still in use.

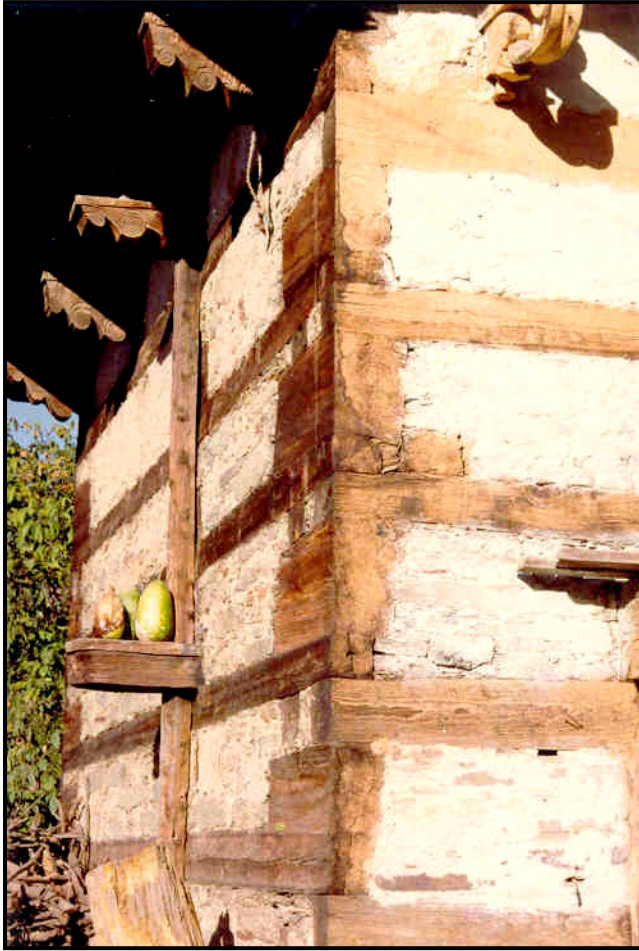
Timber beams are used as tie-bands. Long flat stones at the corners provide extra reinforcement.

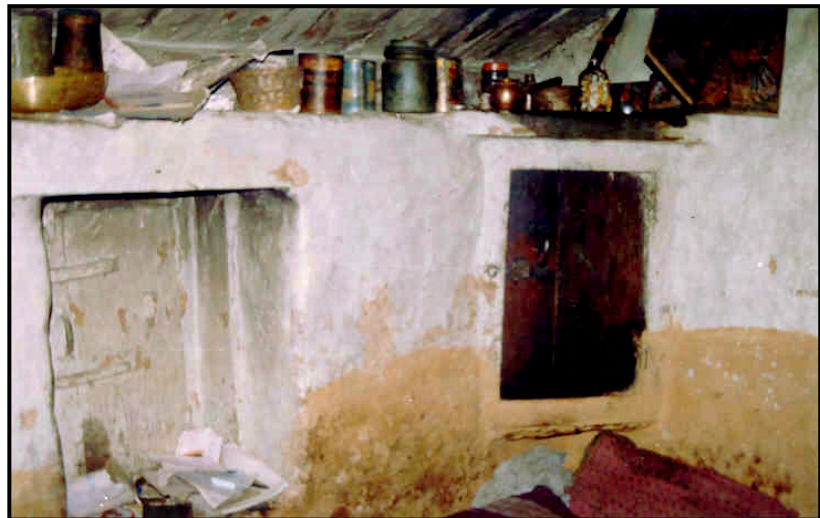
Corners bear maximum stresses. In this case, timber corner braces have been used for reinforcement. The extra space created becomes a cupboard

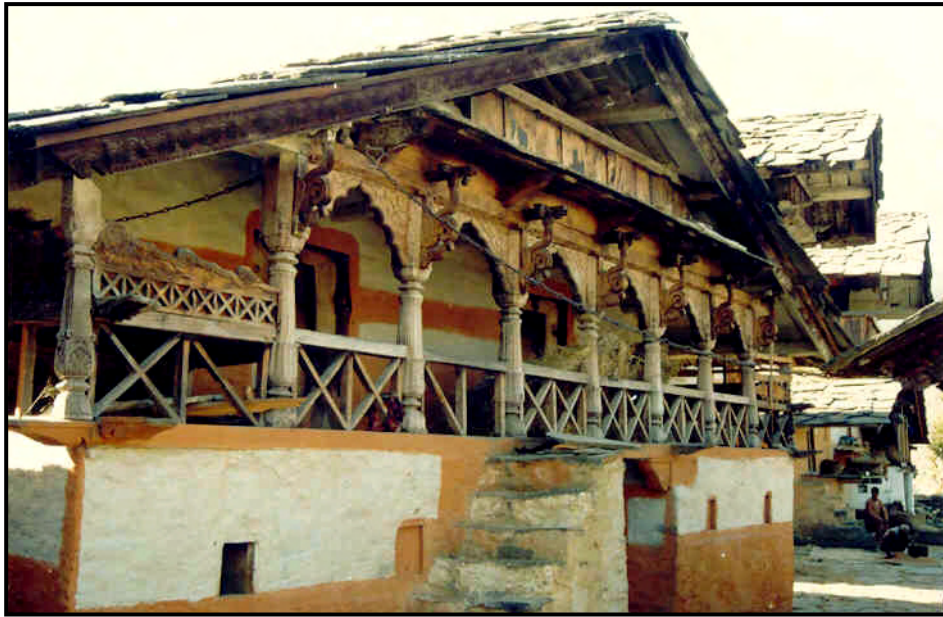
Aesthetics are an important feature of the traditional architecture in the mountain districts of the Central Himalayas. The diagonal braces provide support to wooden columns and intricate carvings provide an artistic touch.

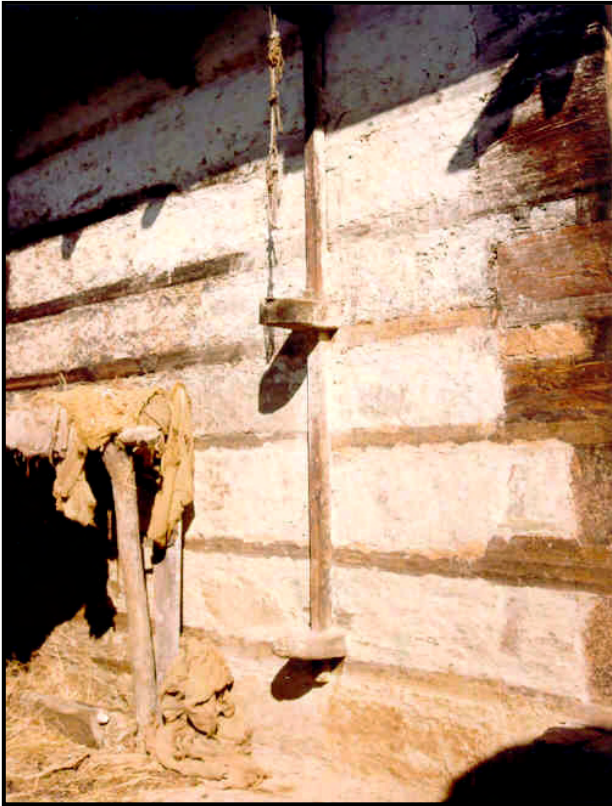
Traditional houses in Garhwal have thick walls, which provide insulation against the winter cold. These walls are often built in two separate layers, since long stones are not readily available.

The photograph above shows the use of horizontal wooden blocks and vertical blocks and vertical columns to tie the inside and the outside.

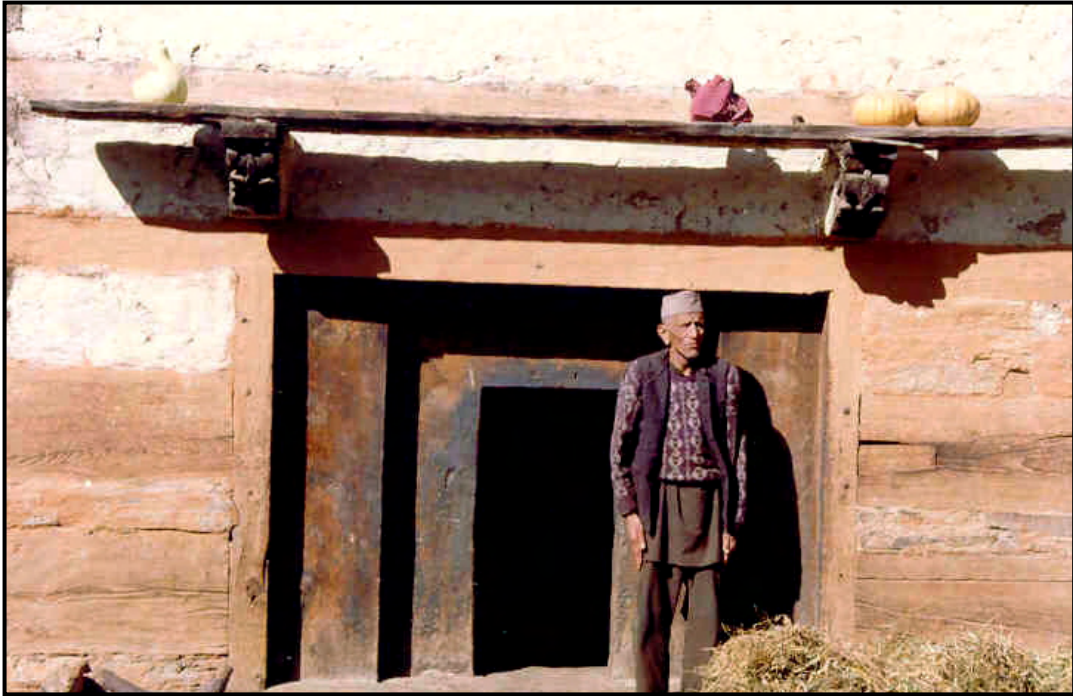
Small openings are an important quake-resistant feature

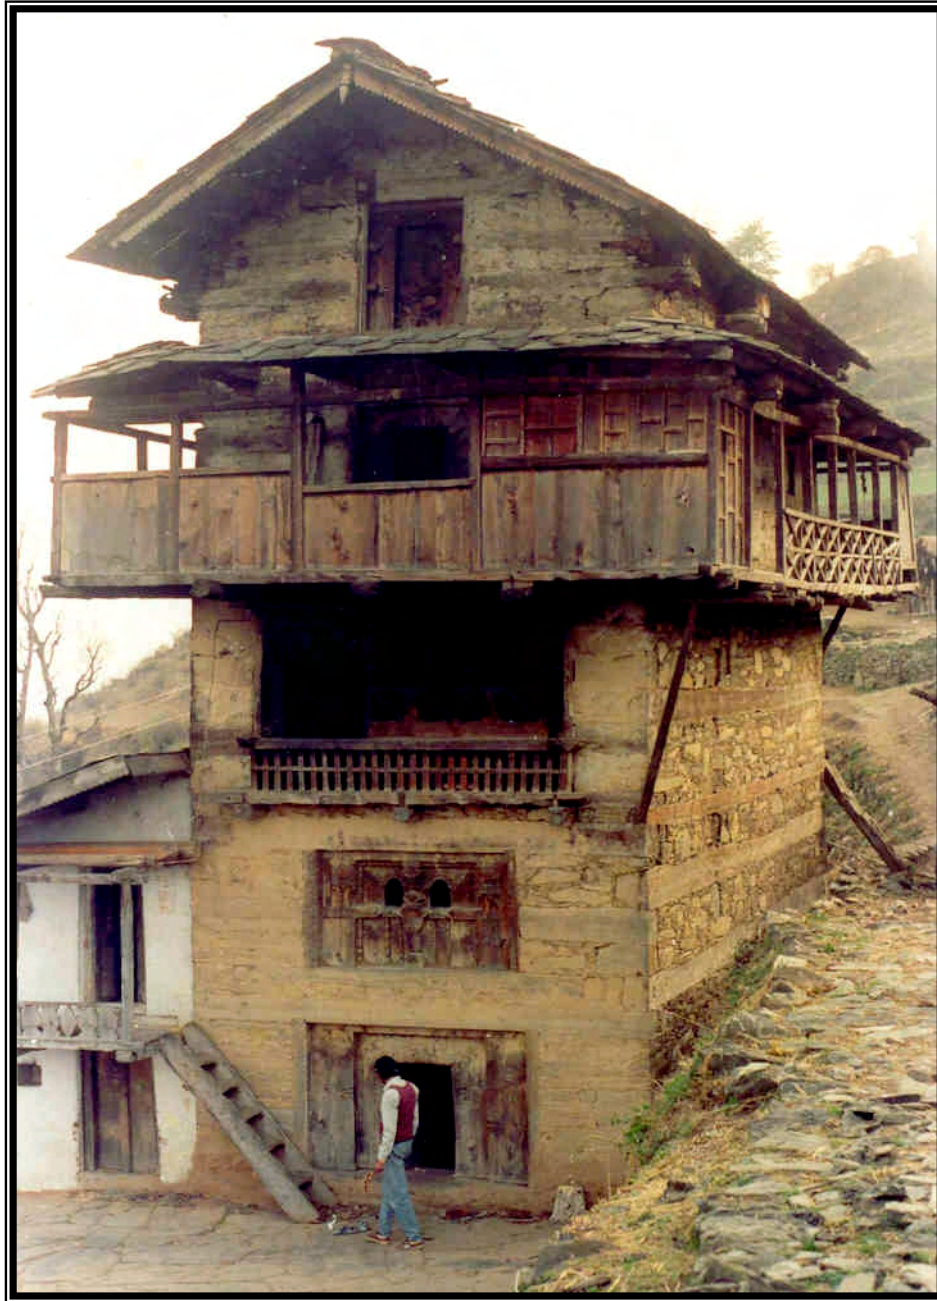
A five storeyed house, about 125 years old in Raithal village, Uttarkashi, that withstood the earthquake in 1991. Most of the other houses in the vicinity were partially or fully damaged.

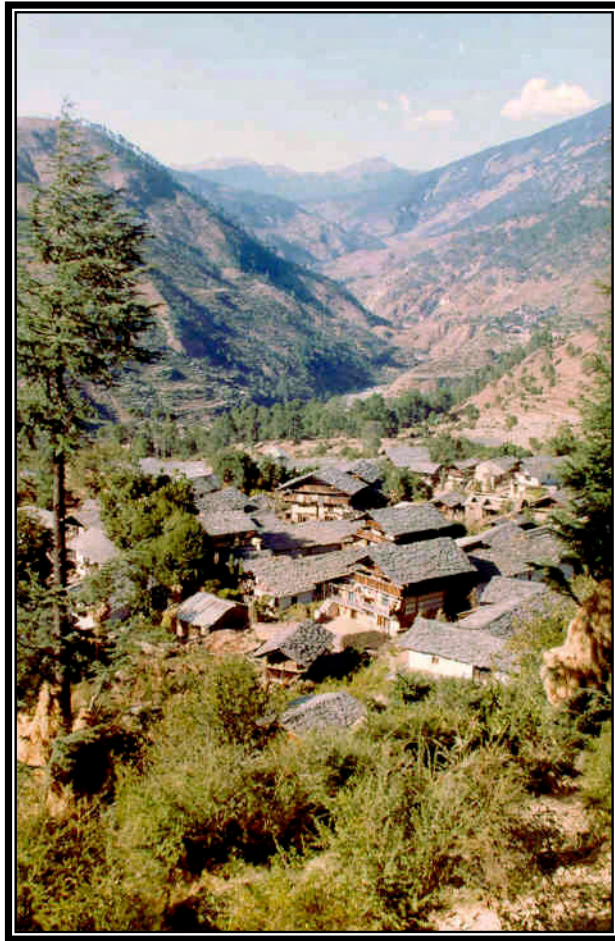
Traditional earthquake-resistant houses in Nandgaon village, Yamnotri valley. These houses are more than 100 years old. The main construction materials are mud , stones and timber.

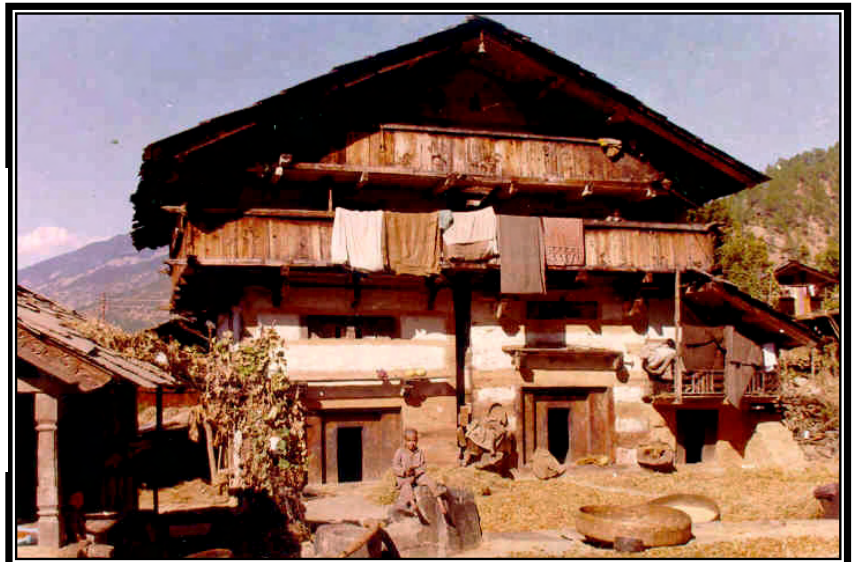
One of the four storeyed earthquake resistant structures in Nandgaon. This 125 year old structure is still in use.

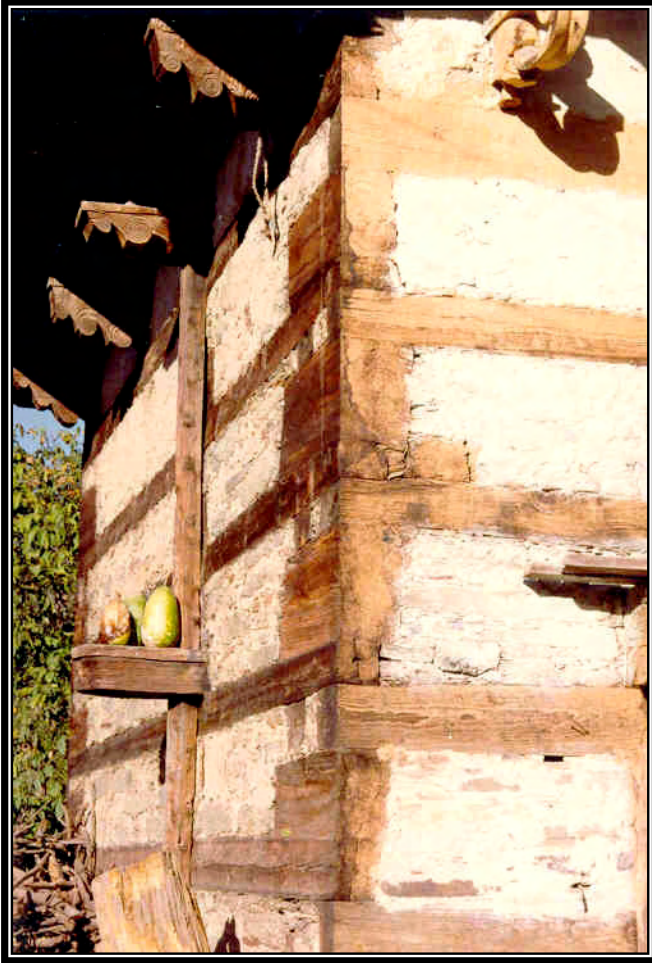
Timber beams are used as tie-bands. Long flat stones at the corners provide extra reinforcement.

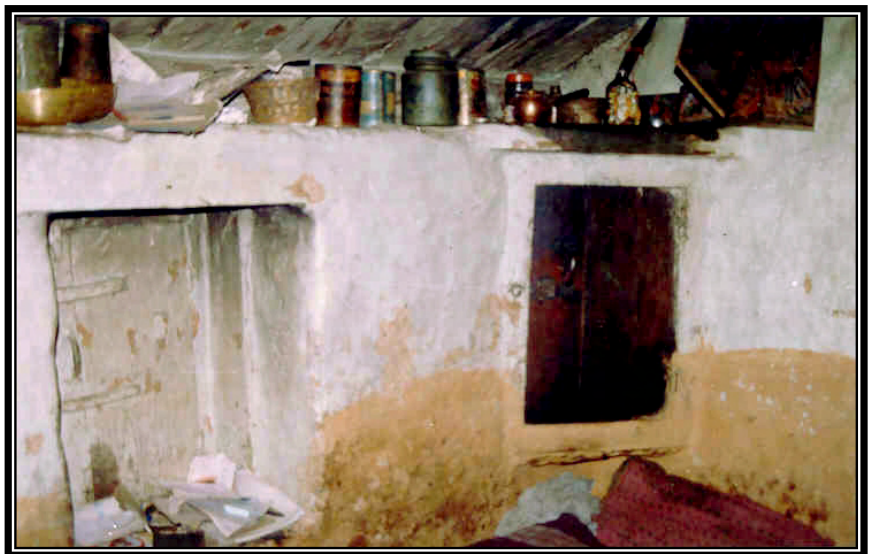
Corners bear maximum stresses. In this case, timber corner braces have been used for reinforcement. The extra space created becomes a cupboard

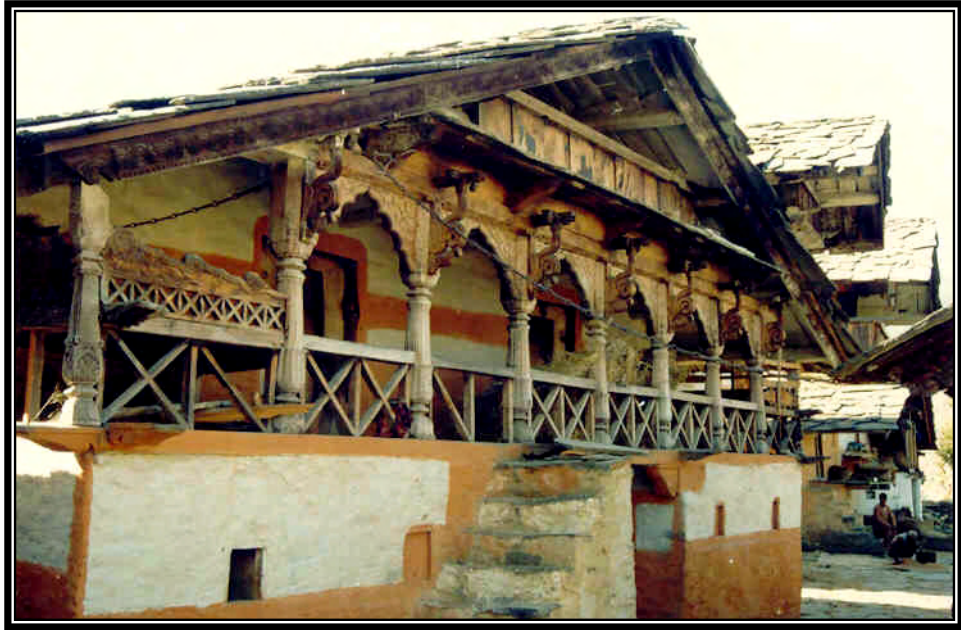
Aesthetics are an important feature of the traditional architecture in the mountain districts of the Central Himalayas. The diagonal braces provide support to wooden columns and intricate carvings provide an artistic touch.

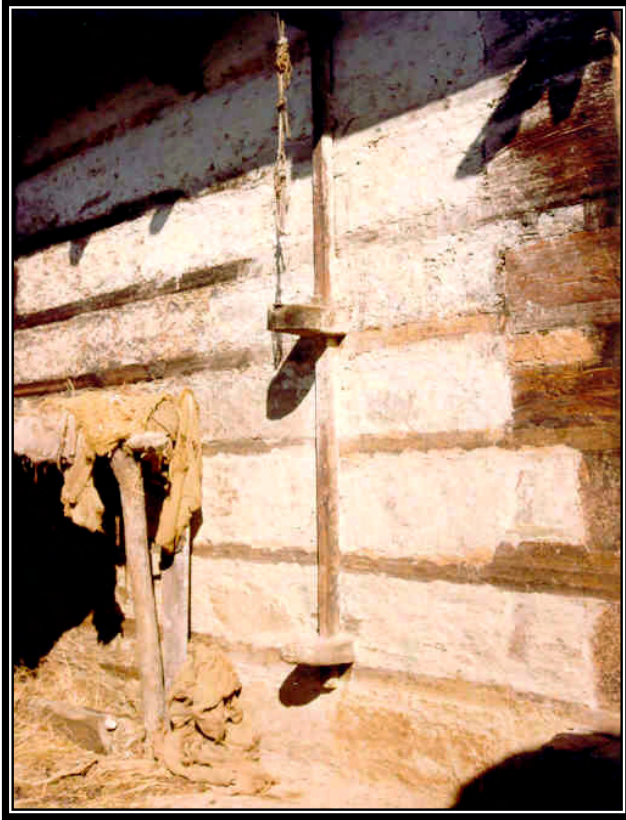
Traditional houses in Garhwal have thick walls, which provide insulation against the winter cold. These walls are often built in two separate layers, since long stones are not readily available.

The photograph above shows the use of horizontal wooden blocks and vertical blocks and vertical columns to tie the inside and the outside.

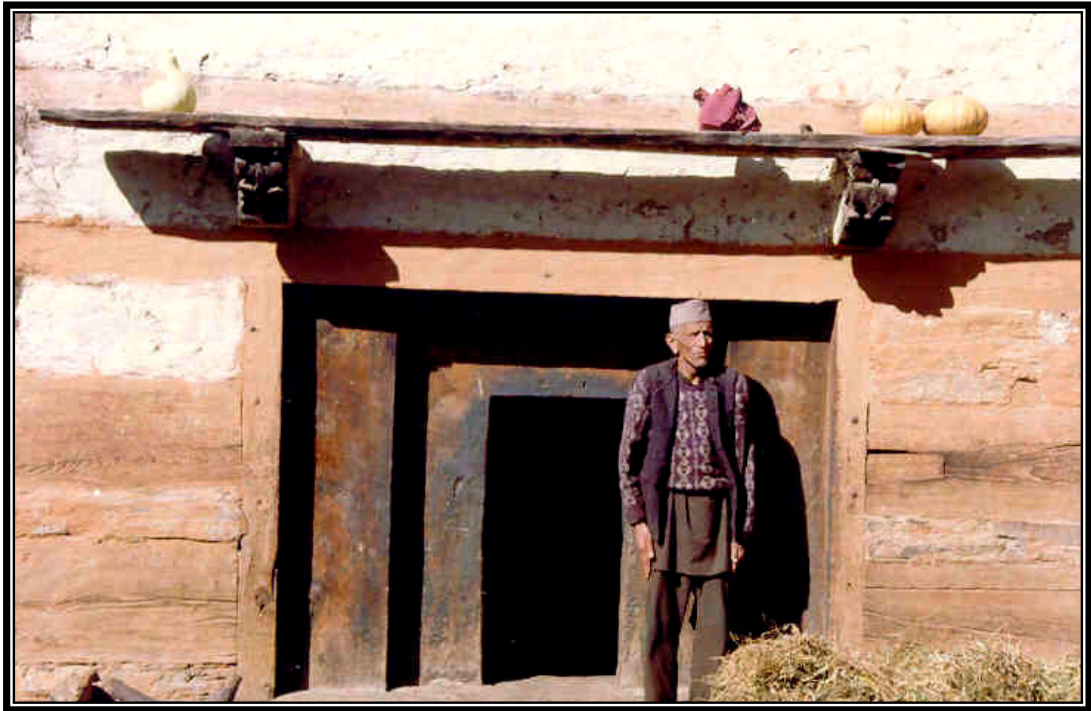
Small openings are an important quake-resistant feature
